**Loss of Pitch Control on Takeoff
Emery Worldwide Airlines, Flight 17
McDonnell Douglas DC-8-71F, N8079U
Rancho Cordova, California
February 16, 2000**

NTSB/AAR-03/02

**National
Transportation
Safety Board**
Washington, D.C.

The National Transportation Safety Board determined that the probable cause of the accident was a loss of pitch control resulting from the disconnection of the right elevator control tab. The disconnection was caused by the failure to properly secure and inspect the attachment bolt.

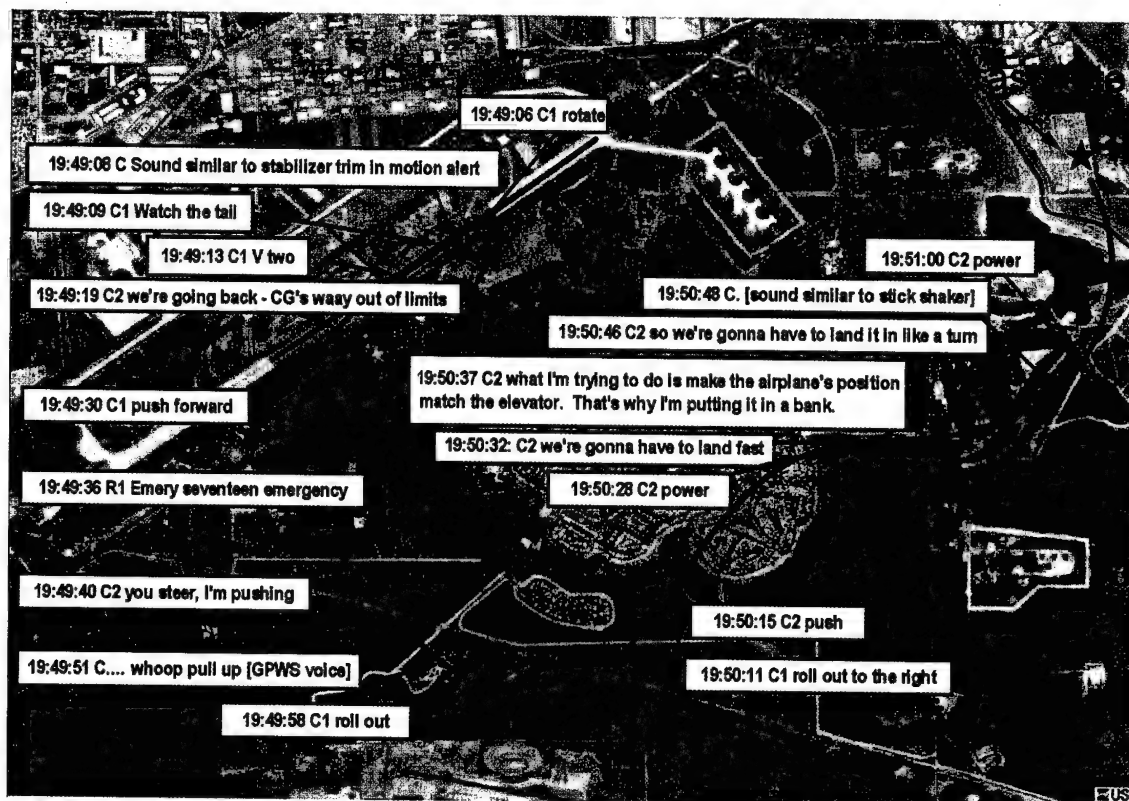
The airplane impacted the ground in a left-wing-low, slightly nose-up attitude in an automobile salvage yard, about 1 mile east of the departure runway. Figure 1 shows the airplane's ground track, with selected CVR comments, during the accident flight. (For additional information regarding CVR comments, see the CVR transcript in appendix B).

Figure 1. The airplane's ground track, with selected CVR comments, during the accident flight.

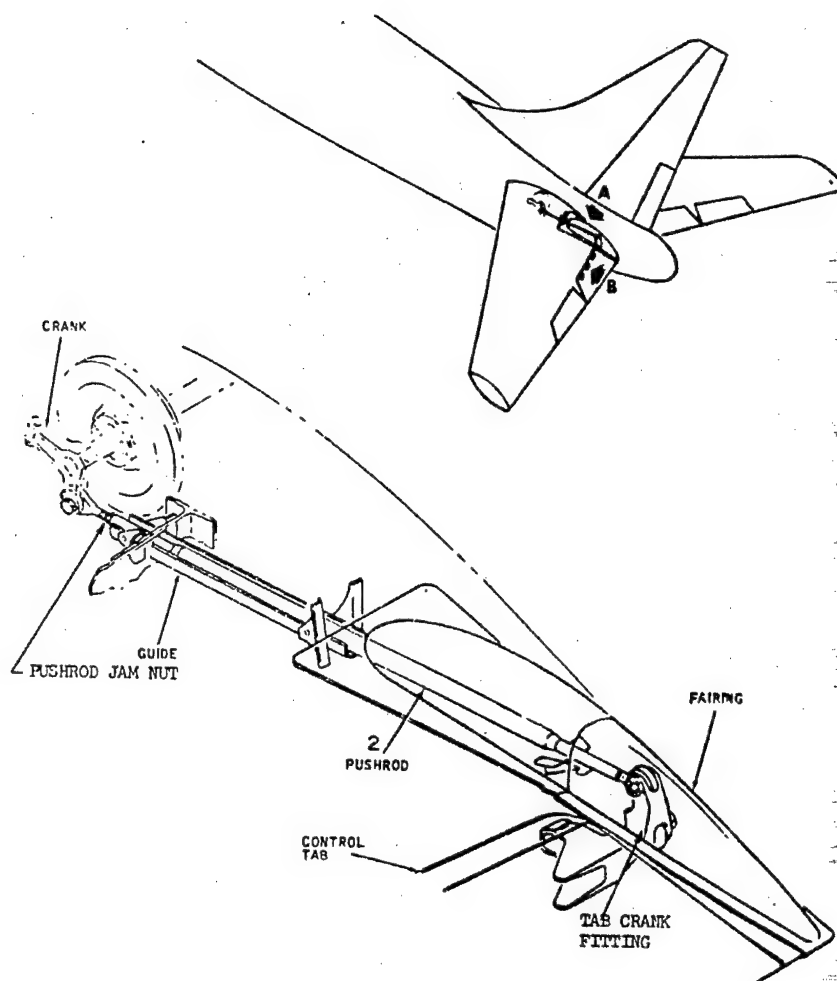
Each elevator control tab is hinged to the inboard trailing edge of the associated elevator surface, then connected by a mechanical linkage (including a crank fitting, pushrod, and bellcrank assembly) at the inboard edge of the tab to the flight control system on that side of the airplane. Figure 2 is a diagram of the elevator control tab installation. The elevator control tabs are in their neutral position when they are in line with the elevator surfaces and should have a maximum TEU deflection of $8.5^\circ \pm 0.5^\circ$ and a maximum TED deflection of $26.5^\circ \pm 0.5^\circ$ from that neutral position.

Figure 2. A diagram of the elevator control tab installation.

(See figure 2, in section 1.6.2, for a diagram of the elevator control tab installation.) The right control tab pushrod was recovered separately, with its aft rod end (which would normally have been bolted to the tab crank fitting) intact. Examination of the forward edges of the elevator control tab crank fitting lugs revealed evidence of repeated contact damage (including gouge marks and indentations). (Figure 9 is a photograph of damage to this area.) The internal surfaces of the pushrod aft rod end bearing and the bushings in the crank fitting lugs showed no visible signs of damage or deformation. The bolt and associated hardware that normally secures the right elevator control tab pushrod to the tab crank fitting⁶¹ was missing and not recovered.

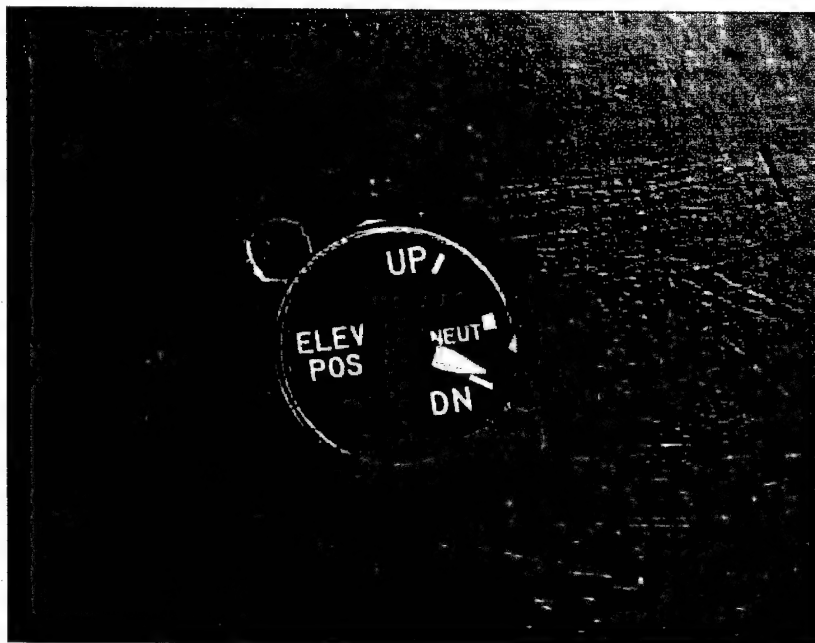
The DC-8 EPI is a 1-inch diameter circular cockpit gauge with a pointer needle and index markings for UP, DN (down), and NEUT (neutral) positions to indicate the position of the elevators. When the EPI is properly calibrated, the up index mark should correspond to the maximum TEU elevator surface position of 27° and the down index mark should correspond to the maximum TED elevator surface position of 16.5° TED. A narrow white band adjacent to the NEUT index mark indicates an elevator surface position between 0° and 5° TEU. Figure 3 is a photograph of an EPI gauge similar to that on the accident airplane.

Figure 3. A photograph of an EPI gauge similar to the gauge installed on the accident airplane.
